UPDATED LIBERTY THEATRE
FEASIBILITY STUDY
200 PARK AVE, EUNICE, LOUISIANA
APRIL 27, 2023

02 | ARCHITECTURAL NARRATIVE - SITE OBSERVATIONS

SITE OBSERVATIONS

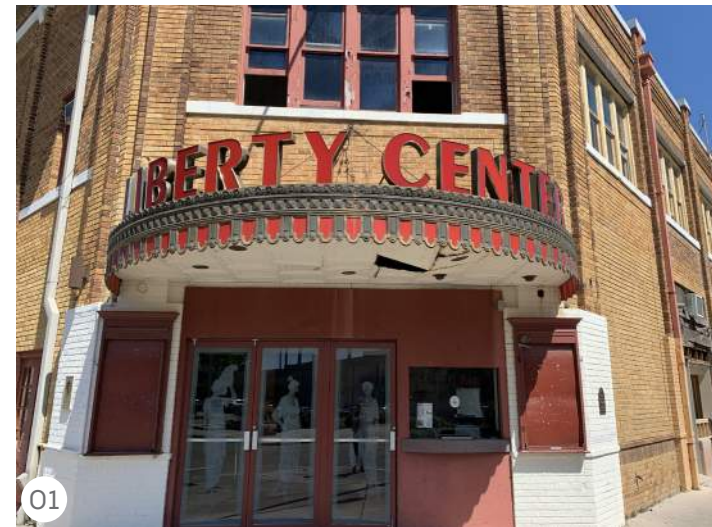
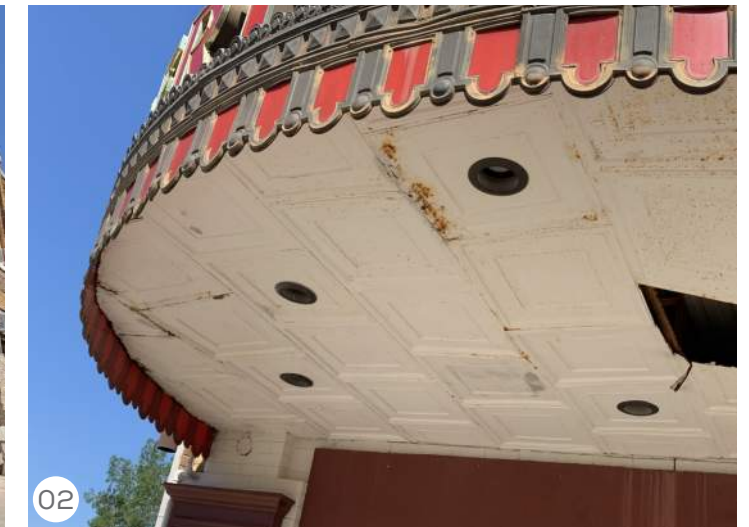
The iconic **entrance marquee** at the main entrance, on the corner of Park Avenue and 2nd Street is showing signs of loose, missing and rusting soffit panels. The recessed downlights do not appear to be operational. OTJ's recommendation is the marquee should be cleaned, restored, and re-lamped. The marquee is an important marker of the main entrance and gives the Theatre a clear main entry. Refer to image 1 & 2

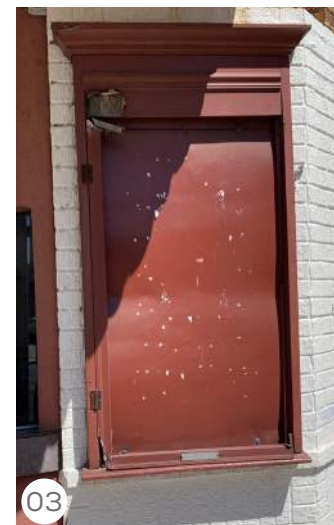
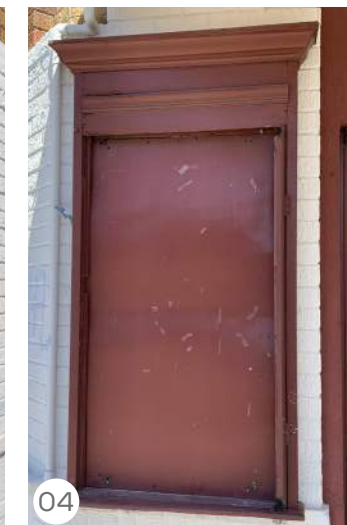
The **Poster Boxes** on either side of the main entrance doors appear to be in fair condition, however they are missing or have damaged poster box doors and glazing. OTJ's recommendation is that the poster boxes be restored, and new doors be provided. We also recommend power be provided to enable the poster boxes to be illuminated. These improvements will present a location for graphics to publicize and promote upcoming attractions. Refer to image 3 & 4

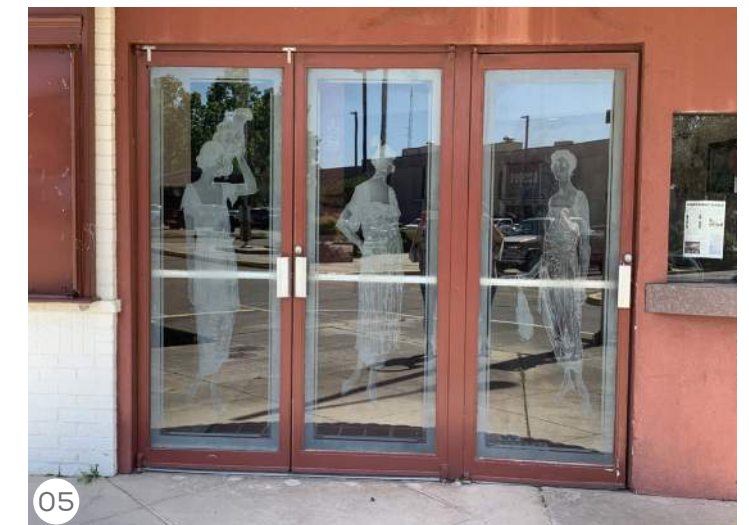
The **main entrance doors**, with glazed panels with etched figurines, make a striking and memorable first impression. We recommend retaining the glazed panels which appear in good condition. We recommend the entrance opening be widened, eliminating the existing **ticket window**. Adding an additional leaf, which will provide for two sets of double doors. We recommend, if possible, restoring the wood stiles and frames or replacing in kind with profiles to match existing. The additional door will need to be a replication to match existing profiles. All doors will need to be providing with new code compliant door hardware. We recommend developing a fourth etched glass figurine design, compatible with the existing glass panels, for the new fourth door leaf. Refer to image 5

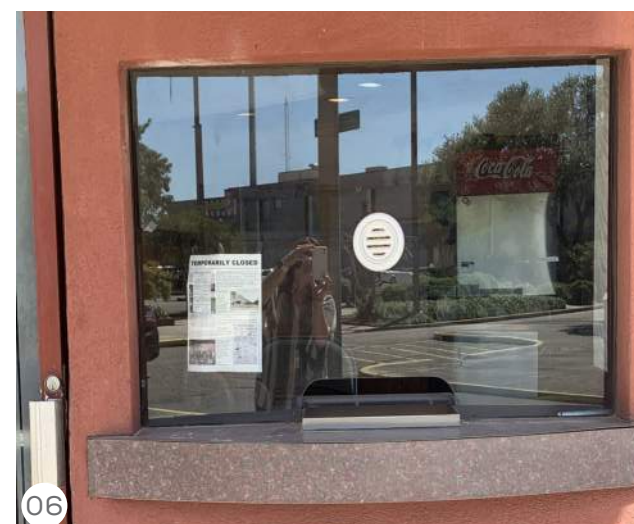
The exterior **ticket window** is to be eliminated to make way for a wider entrance opening. A new Box Office / Ticket Sales area will be created within the Entry Foyer. Discussed further under INTERIOR OBSERVATIONS. Refer to image 6.

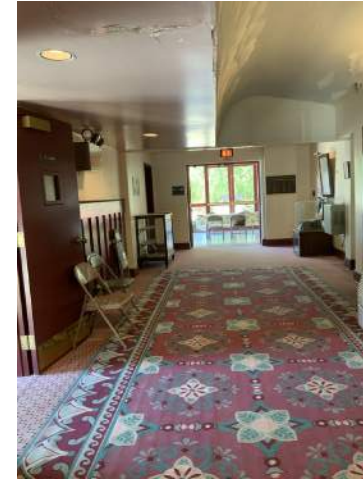
Emergency lighting is provided via emergency fixtures with integral batteries. These fixtures are located throughout the building. Emergency light coverage appears to be inadequate for this building.

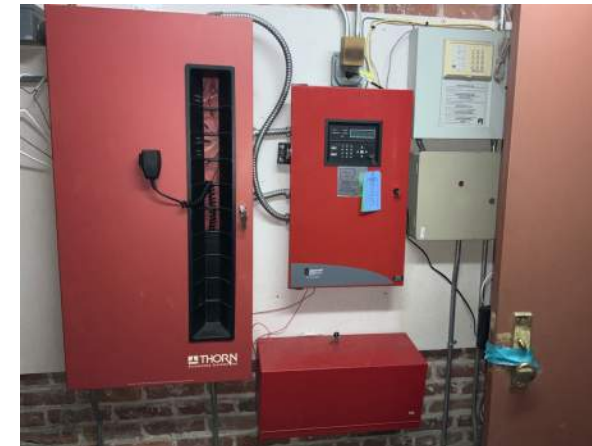
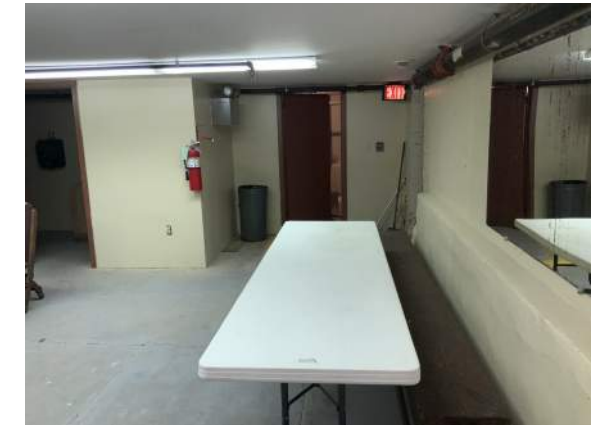
Fire alarm devices appear to be older than the control panel, likely 1990's vintage. These devices should be scheduled for replacement.

Replacement of fire alarm devices is recommended to increase system function and reliability.

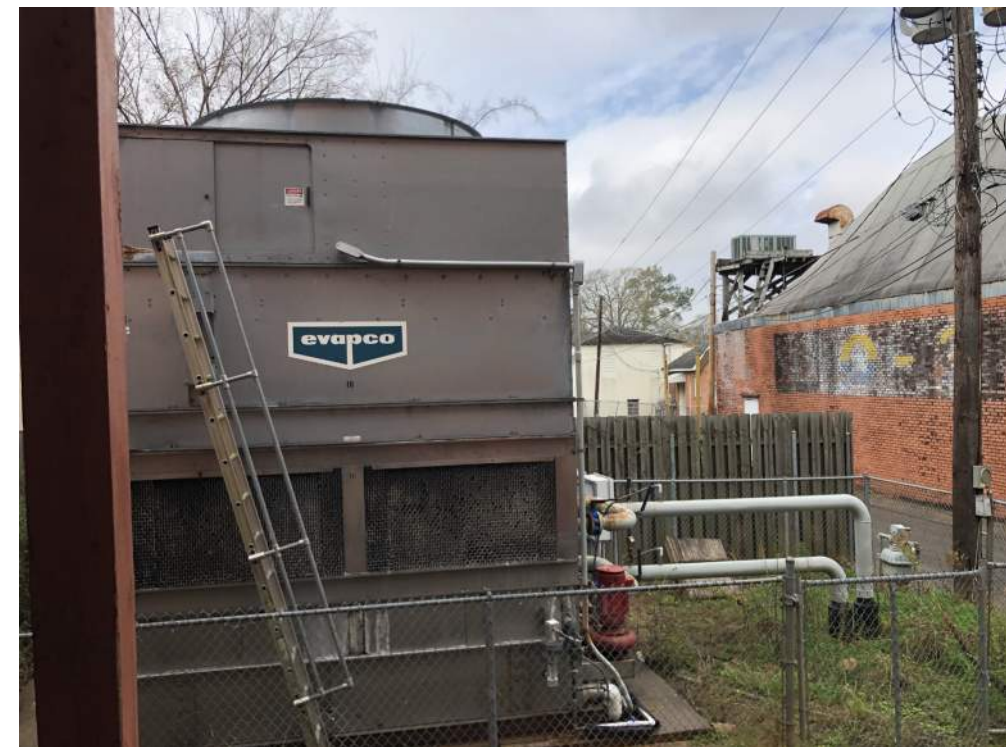
EXHIBIT A - COOLING TOWER

The cooling plant includes a water-cooled chiller (140 tons) with a remote cooling tower. The cooling tower itself is located on-site on the ground at the northwest corner of the property. Refer to the cooling tower photo on the previous sheet (Exhibit A).

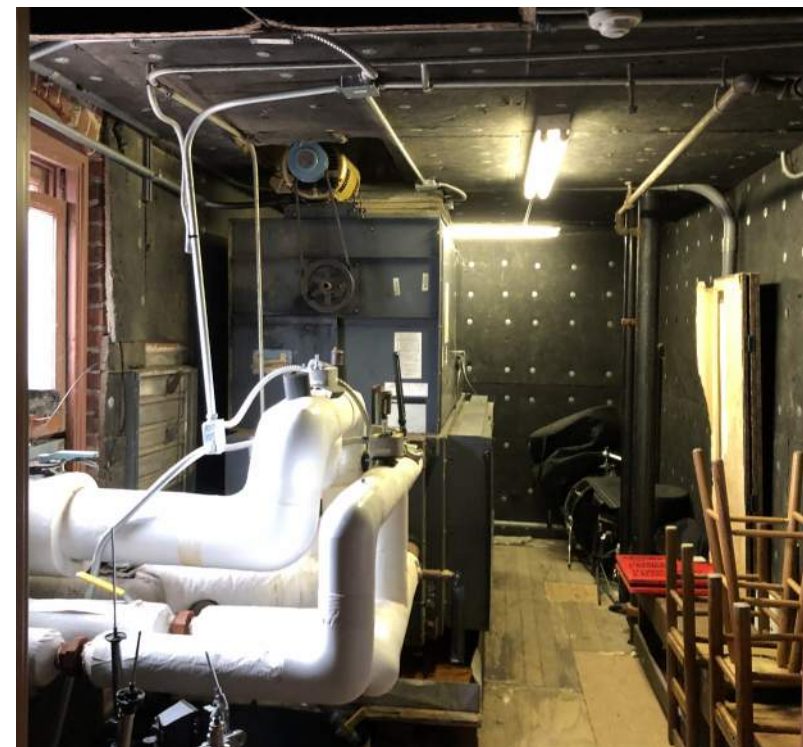
EXHIBIT B - THEATER AIR HANDLING UNIT

Existing: The main theater is conditioned by a single 4-pipe chilled and hot water air handling unit that is located behind the stage at the northwest corner of the building. The air handling is served by a water-cooled chiller, natural gas boiler and circulator pumps that are located off-site in the nearby building called the Prairie Acadian Cultural Center.

We propose replacing the HVAC units with packaged rooftop air conditioning equipment with DX cooling and natural gas heating. This will require structural upgrades to handle the weight of the new units. The reason for rooftop equipment is because the site presents a challenge for adding units on ground level.

The existing ductwork will need to be removed and replaced with new ductwork and diffusers. This will allow for repurposed space above the stage area.
