UPDATED LIBERTY THEATRE
FEASIBILITY STUDY
200 PARK AVE, EUNICE, LOUISIANA
APRIL 27, 2023

02 | ARCHITECTURAL NARRATIVE - SITE OBSERVATIONS

SITE OBSERVATIONS

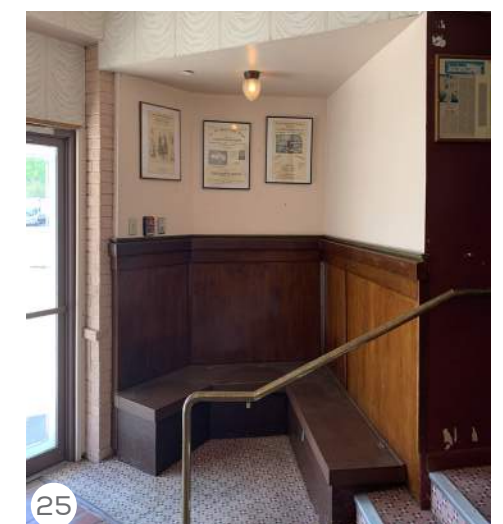
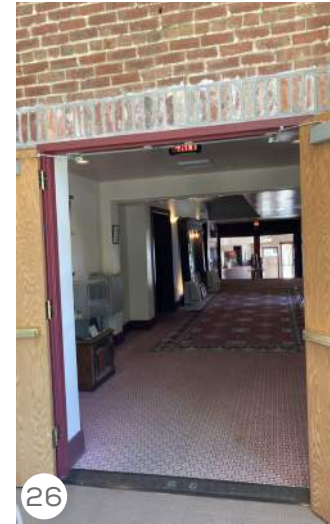
OTJ's observation is that the stair transition between the **Entry Foyer** and the **Lobby** has a negative spatial impact on both spaces. Additionally, it presents an impediment to ADA patrons accessing the venue. OTJ's recommendation, is that the stairs be modified to a single run, with the first tread aligning with face of the walls of the opening between the Entry Foyer and Lobby. The modification to the stairs allows for more room in both the Lobby and the Foyer. To address the congestion concerns and provide an ADA accessible route OTJ recommends modifying the Annex Exit door, at the west, into a second entrance off Park Avenue, accessed via an ADA compliant ramp (as described in EXTERIOR OBSERVATIONS). This would provide for ADA access directly to the Lobby Level. OTJ also recommends removing the wall between the rear of the audience chamber and expanding the Lobby space into the area below the Balcony to create a more open, less compressed Lobby experience. The expanded Lobby will allow space for an optional bar, concessions or food service area. Providing capacity for an 80 person cocktail event with bar or 100 person event without a bar. Adding stair access on both sides of the lobby, and an ADA ramp, in the area along the wall between the Lobby and Audience Chamber, to provide ease of access from the Lobby into the Audience Chamber for all patrons. Similarly, to the Entry Foyer finishes discussion, OTJ recommends working with a decorative finishes restoration conservator to perform investigative work throughout the historic front of house spaces. Walls, ceiling, and trim work in the Lobby to be executed in alignment with the color palette and surface finish recommendations of the conservator. Research historic carpet pattern and color palette for the lobby floors. Refer to images 26 & 27

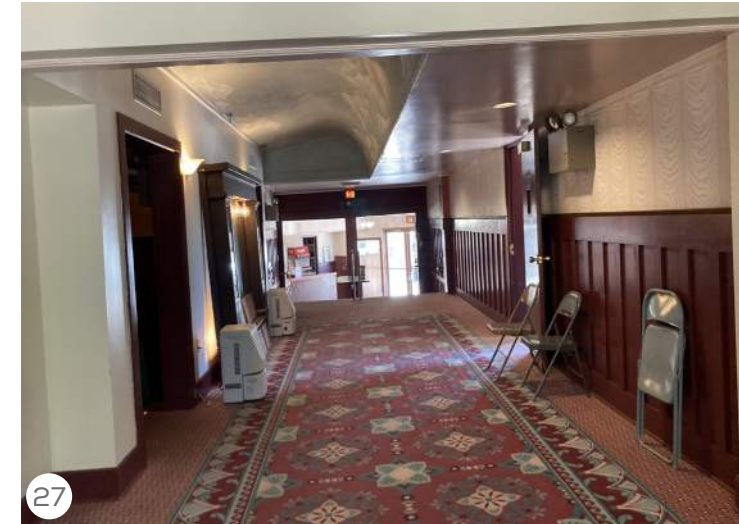
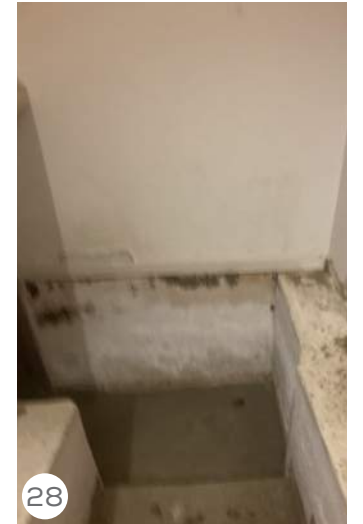
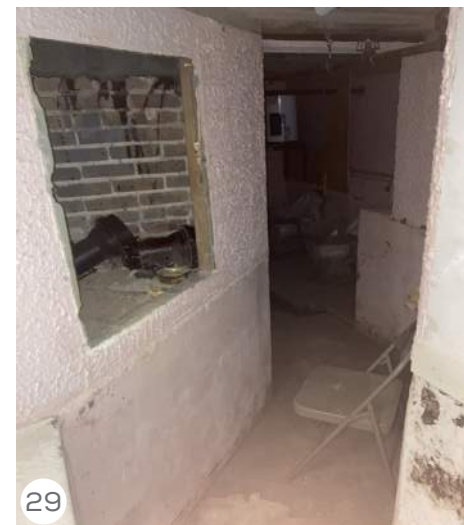
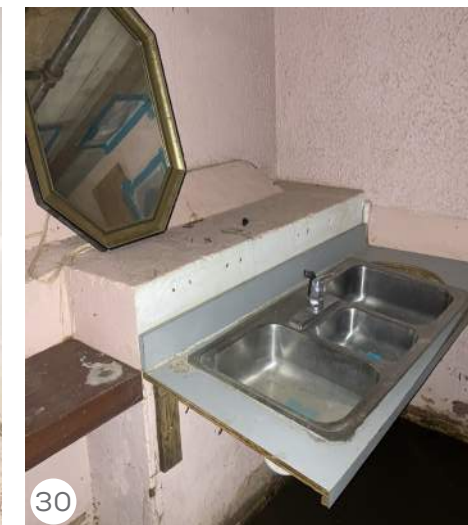
The existing basement level Men's Restroom has been abandoned and closed off and is no longer accessible from the Lobby area. We recommend the Women's Restroom also be abandoned and access closed off. The restrooms do not meet code head height clearance requirements, the stairs to the restrooms do not meet code stair width requirements, the restroom shows evidence of water infiltration, and there are only 2-3 fixtures in each. The work to remedy these deficiencies may not be worth the effort given that the restroom facilities in the Annex are ADA accessible, meet code requirements and exceed plumbing code fixture count requirements for the venue. The void created by closing off the access to the Women's Restroom could be utilized to provide a Merchandise position, as well as some storage for either merchandise or front of house needs at Lobby Level. Refer to images 28-31.

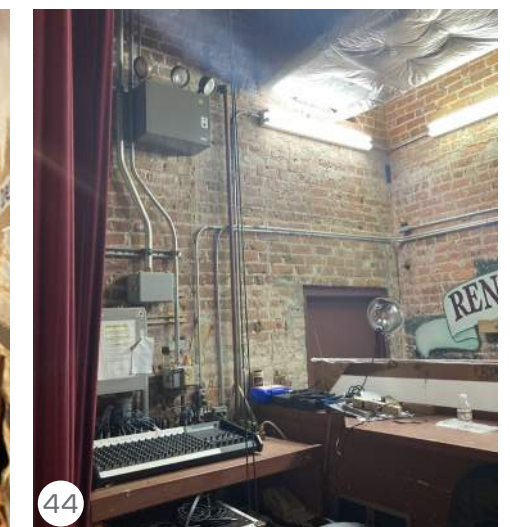
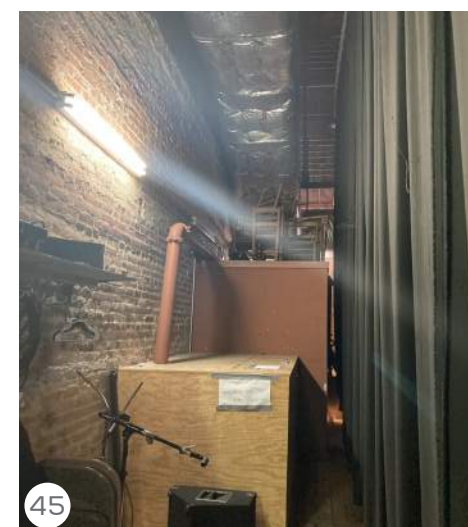
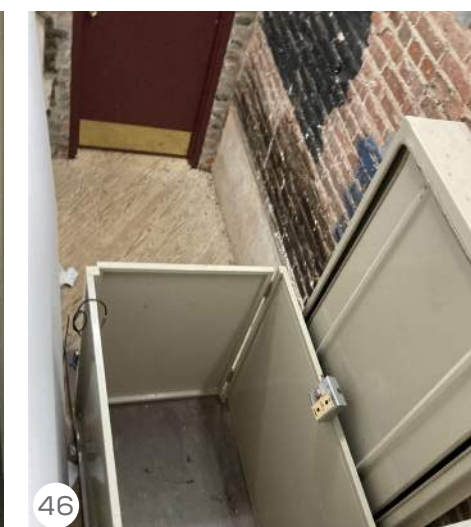
The existing Theatre has very limited back of house support, limited to the area below the stage. Stage access and load in is a challenge with the approximate 5' level change between grade and stage level. With the removal of the cooling tower there is property available at the northwest corner to improve back of house support space and flow. OTJ are proposing a bump out that would provide a modest back of house support area. This area could be expanded as needs and funds become available. The current recommendation shows a small receiving area, some limited storage space, ADA access between front of house and back of house, stair access to stage. The area below stage has limited head room clearance, which does not comply with code. We recommend that this be used primarily as a utilitarian area (storage). It would be grandfathered as an existing space, and used as a Multi-Purpose space, with a sink, shower and toilet being added. The newly created back of house bump out at the northwest corner could also house a catering prep and storage area to support the Bar / Café area. A dedicated delivery / parking area off the rear alley will improve back of house functionality, particularly with regards to catering and performer back of house load-in. Refer to images 47-49.

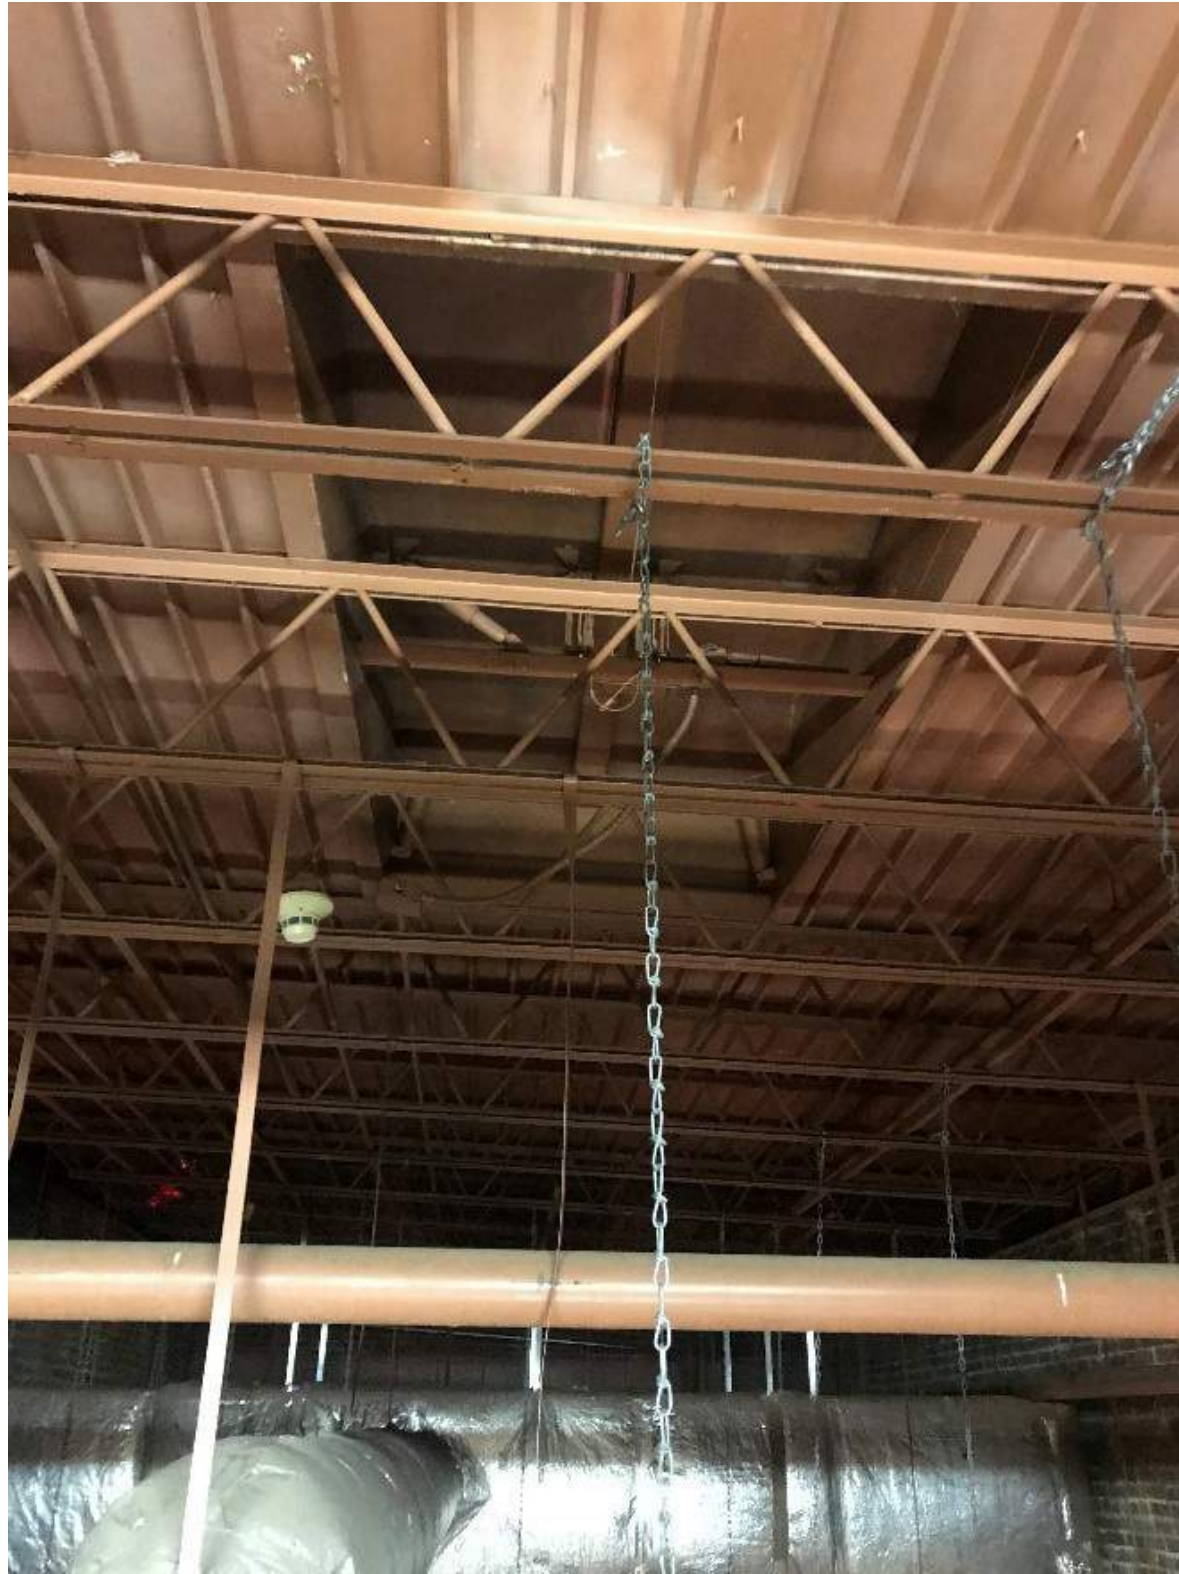
STAGE ROOF FRAMING

The roof was also replaced with open web joist and the current curtain drops hang from the joist. There is a gallery on each side at about 10' and just below the roof.

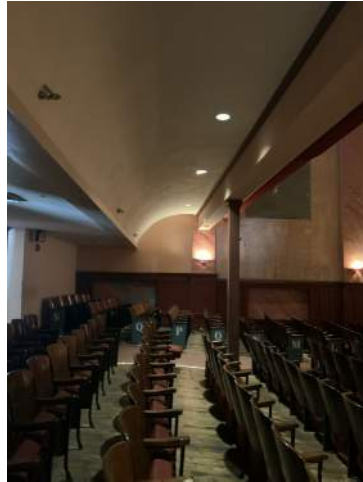
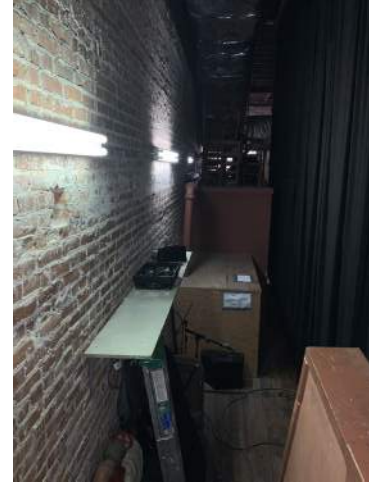
The lighting in this facility consists of a combination of incandescent and fluorescent light fixtures.

Replacement of all general-purpose lighting fixtures is recommended for modernization, reduced energy consumption, and compliance with current energy code requirements.

Recommend replacing all existing light fixtures and installing LED fixtures as well as utilizing LED fixtures in areas and spaces that are being added to the project.

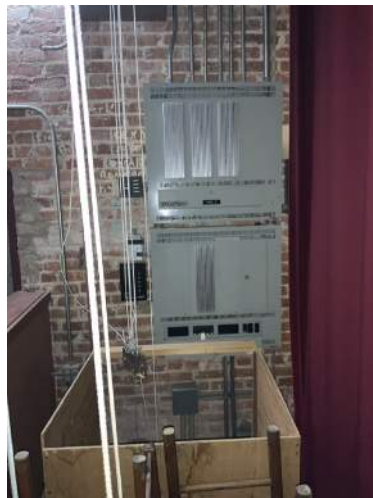
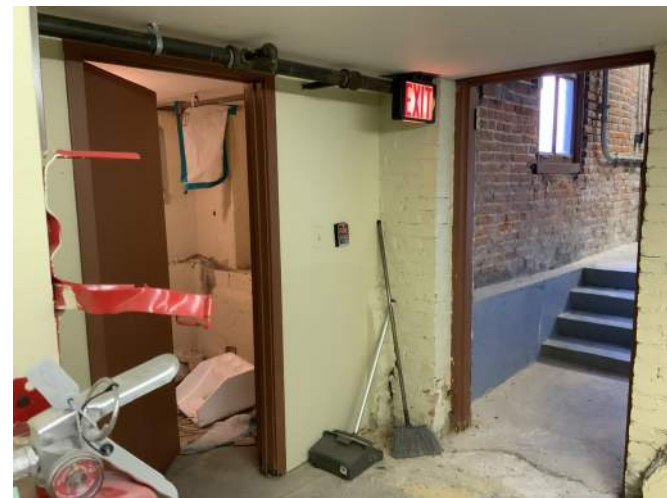
A mixture of lighting controls have been utilized throughout the building. General lighting is controlled from wall mounted light fixtures. Performance stage lighting is controlled from lighting dimmer panels located on a wall stage left. Individual light switches are located in or near the spaces that they control.

General lighting controls should be replaced and upgraded to dual technology ultrasonic and motion activated sensors to meet current lighting code requirements.

Performance stage lighting controls should be evaluated to determine if the existing controls will provide satisfactory results for the intended use and functions of the stage. Functional condition, operational appropriateness, and remaining life expectancy of the current stage lighting controls will need to be investigated.

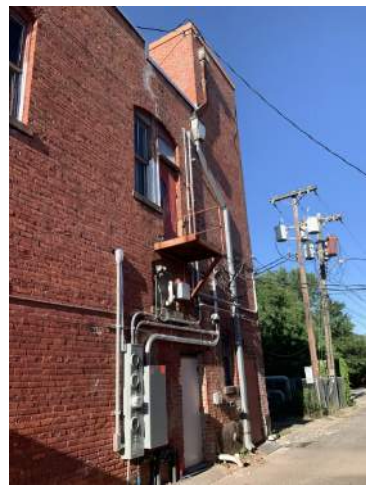
Telephone/data cables enter through the back of the building.
